# BELZONA NON-SKID SYSTEM REMOVES SLIP AND FALL HAZARD

ID: 289

Quarry tiled floor in a hospital dish washing area.

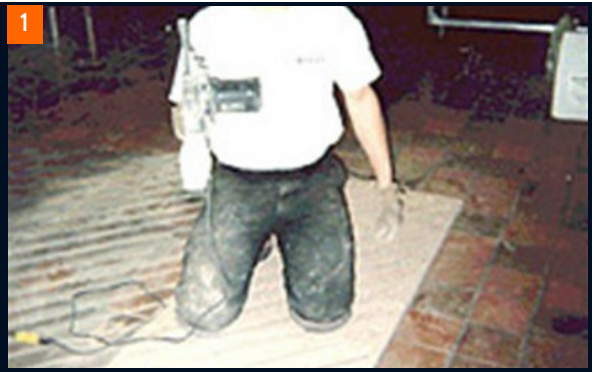
1. Surface preparation with template
2. Glaze removed from quarry tile floor
3. Masking tape removed after the application is complete
4. Completed application of grip system

The application was carried out in accordance with Belzona Know-How System Leaflet FPA-8.
