# BELZONA PERFORMANCE IMPROVEMENT PROGRAM (PIP) CUTS RUNNING COSTS DRAMATICALLY

Submersible potable water booster pump

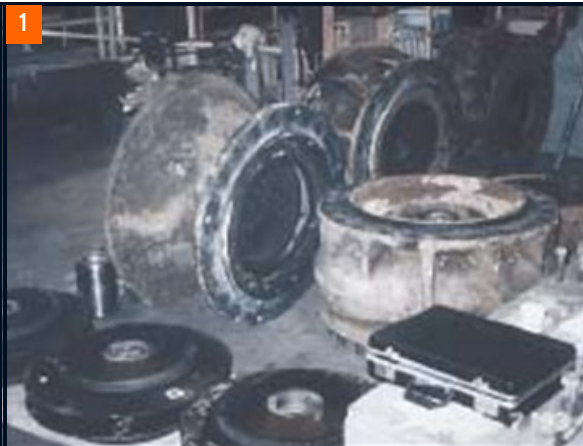
Reduced flow and pressure coupled with motor overheating

The pump unit was identified for potential overhaul while still in service due to reduced output and overheating of the drive motor, a characteristic of reduced hydraulic performance. When the unit was removed and disassembled for inspection, considerable erosion had occurred on the diffuser bowls, which were also badly deteriorated from the effects of nodal growth and corrosion. By utilizing Belzona computer generated overhaul techniques specific to this pump type and its operating conditions, substantial savings in running costs - approximately \$55,000/year, coupled with sustained high levels of performance, increased output and long term protection were achieved.

1. Deteriorated pump components
2. Performance improvement information
3. The completed application following refurbishment

The application was carried out in accordance with Belzona P.I.P. computer generated engineering specification from detailed information supplied by the end user.
