# BELZONA FOR THE REPAIR OF STEP NOSINGS

ID: 290

Steps at a furniture manufacturing facility leading to a loading area.

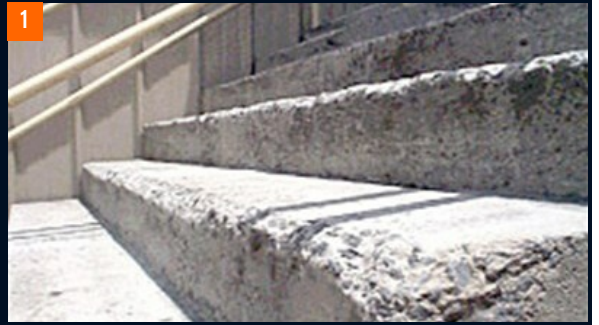
The step nosings leading to a loading area became rounded from constant traffic and improper handtruck usage.

1. Damage to step nosings
2. Belzona 4911 (TX Conditioner) applied to steps
3. Peeling tape off to reveal Belzona 4411 (Granogrip)
4. Completed application

The application was carried out in accordance with Belzona Know-How System Leaflet FPA-8.
