# BELZONA REPAIRS DEWATERING CENTRIFUGE

Worn flights on a Humboldt Dewatering Centrifuge.

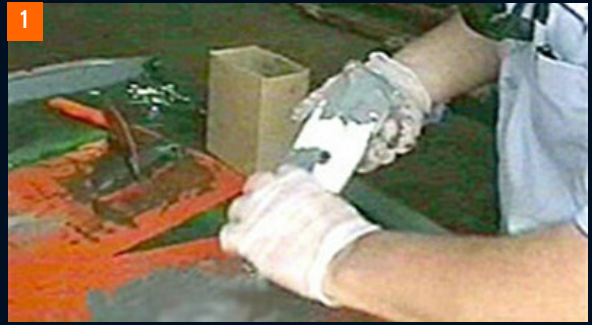
1. Applying Belzona 1111 (Super Metal) to tiles
2. Fastening tiles to the flights
3. Tiles installed along circumference of flights
4. Belzona 1811 applied over bolts and inlet port areas
