# BELZONA KEEPS ENTRANCE WAY STEPS LOOKING GOOD AND SAFE

ID: 292

Step nosings along a very visible entrance way.

Agency building - Houston, Texas U.S.A.

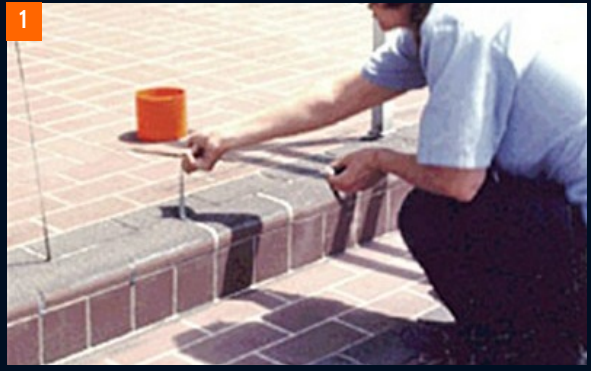
1. Pulling the tape while the Belzona 4411 is still wet
2. View of entire area
3. Close-up view of completed application

Belzona® 4411 (Granogrip) was applied by brush in conjunction with Belzona® 9221 (Surefoot Aggregate) on the nosings of the quarry tile steps. 1/4 inch tape was cut and placed over the grout lines of the tile to simulate the quarry tile appearance. This area is high visibility for visiting dignitaries and tourists, so emphasis was placed on safety and cosmetics.
