# BELZONA EMERGENCY PIPE REPAIR AT SCHOOL

ID: 2927

Water pipe in a school boiler room

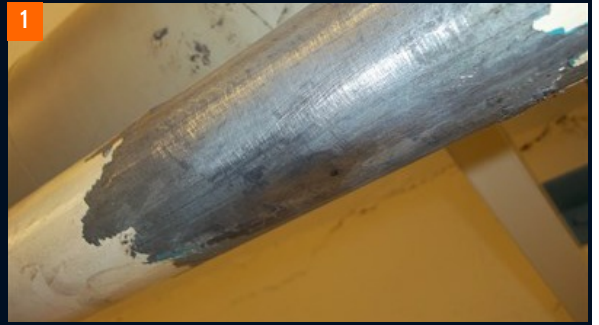
Two small pin holes had appeared under the paint in the main water pipe. Water was now leaking onto the floor creating a slip hazard over a large area.

1. Surface preparation
2. Application of Belzona 1291 to stem the leak
3. Belzona 1291 being held in place with tourniquet during cure
4. Belzona 1221 applied with Belzona 9341 (Reinforcement tape) over the Belzona 1291 to complete the repair
