# BELZONA SUCCESSFULLY REFURBISHES SCHOOL STEPS

ID: 2928

Steps over wash room in school

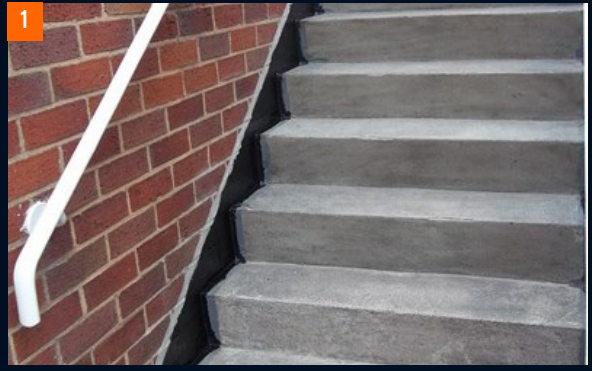
1. Application of Belzona 5811 to walls.
2. Application of Belzona 5811 to steps.
3. Complete encapsulation of steps and walls.
4. Completed application with Belzona 4411 on step noses.

Application was carried out in accordance with Belzona Know How System Leaflet FPA-8
