# BELZONA REFURBISHES SCHOOL STEPS

ID: 2929

Access steps to roof of school with wash room underneath.

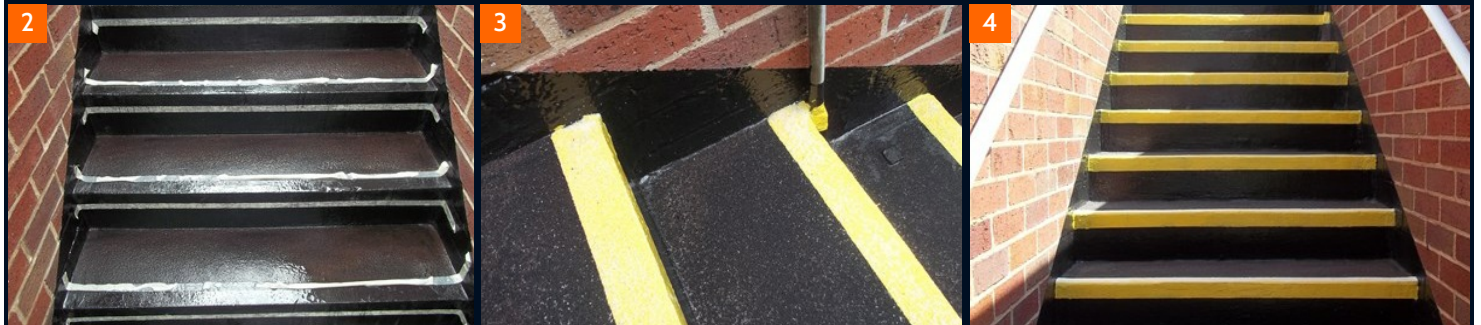
1. Application of Belzona 5811 to walls
2. Application of Belzona 5811 to steps
3. Complete encapsulation of steps and wall
4. Completed application with Belzona 4411 on step noses

Steps were allowing water into the wash room below so needed to be sealed. Also access to the roof was needed so elimination of any slip hazards had become an issue.

Repairs were carried out over two days and have now provided the school with safe and waterproof steps. Following the success of this repair, the customer has since treated several other steps on the site with Belzona 4411.
