# BELZONA REPAIRS WATER JET FLANGE AREA

ID: 2930

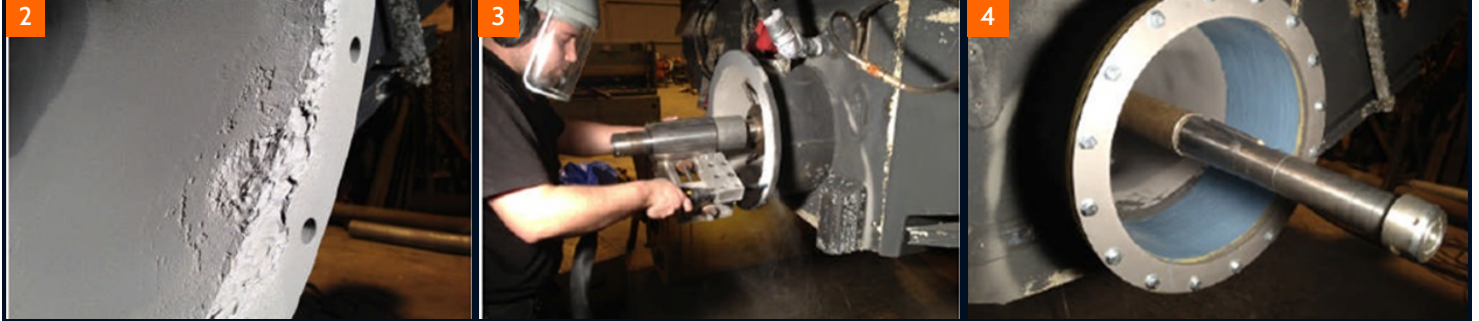
The water jet tunnel was suffering from cavitation and corrosion the flange holding the impeller housing in place. The most severe damages were found on the flange face and extended 20 cm inwards. Additionally the flange face was found to be distorted.

1. The damaged water jet unit
2. A close-up of the damage
3. Machining down the flange surface after rebuilding with Belzona 1111
4. completed application after coating with Belzona 1341

Application was carried out in accordance with Belzona Know-How system Leaflets VPF-1 & 2. Flange face and cavitation erosion was rebuilt with Belzona® 1111. critical clearances were machined before applying Belzona® 1341 for overall erosion corrosion protection.
