# BELZONA REPAIRS DAMAGED FLOOR AT CIDER PLANT

ID: 2931

Inspection hut floor in cider storage tank area

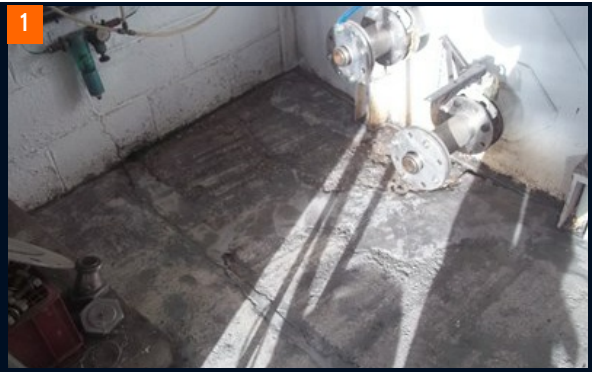
Due to spillage of cider concentrate the concrete floor had begun to break up and created health and safety issues with trips and slips.

1. Damaged floor
2. Application of Belzona 4131 including conditioner to ensure maximum adhesion
3. Complete floor repaired with Belzona 4131
4. Application of Belzona 5231 completed
