# BELZONA REPAIRS DAMAGED FIRE ESCAPE STEPS AT SCHOOL

ID: 2933

Steel fire escape steps

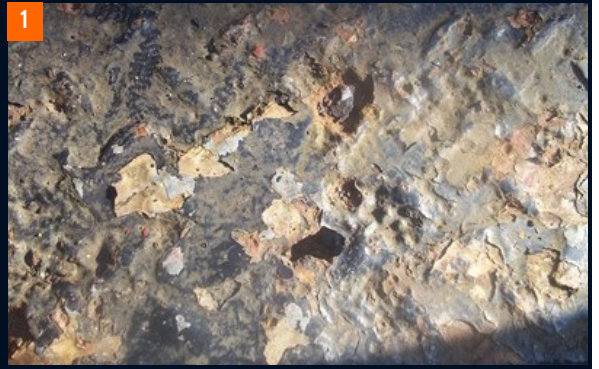
Due to age and weathering the steel plates had become holed and badly corroded creating a safety hazard.

1. Corroded & holed steps
2. Surface preparation
3. Holed steps repaired with Belzona 1111
4. Completed steps with Belzona 5811 applied and nosings blinded with Surefoot Aggregate
