# BELZONA TAKES OFF AT THIS INTERNATIONAL AIRPORT

ID: 294

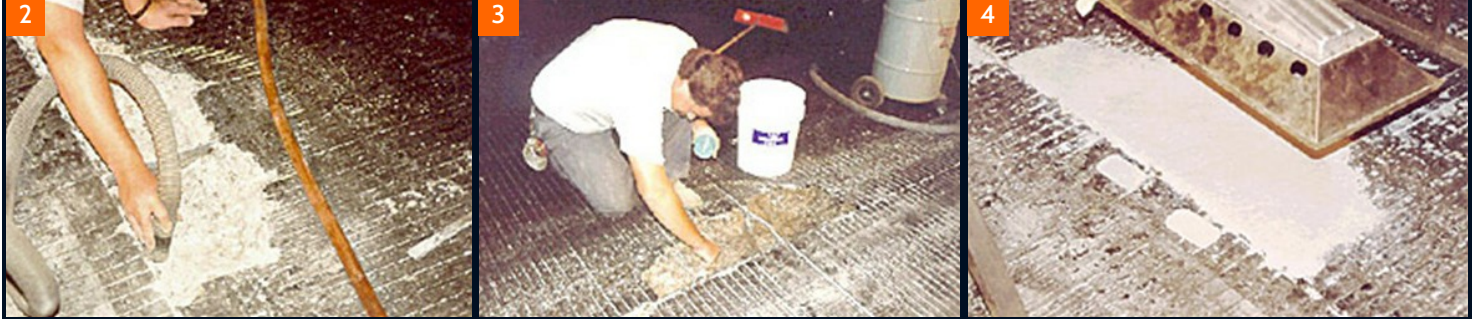
Certain sections of the runway and ramps were spalled from both thermal cycling as well as mechanical damage from constant aircraft traffic.

1. Spalled concrete on runway
2. Surface prepared by chipping loose concrete
3. Conditioned with Belzona 4911 (Magma TX Conditioner)
4. Curing of completed repair being accelerated with heat

Belzona® 4111 (Magma Quartz) was mechanically mixed after the damaged areas were prepared and thoroughly conditioned. The repair material was hand applied and accelerated with infrared lighting to sufficiently cure in the scheduled four-hour downtime. Nine other repair materials were tried, but all failed because of a combination of slow cure times and poor adhesion characteristics.
