# BELZONA IMPROVES PROTECTION AT BASE OF CHIMNEYS

ID: 2946

Three Chimneys for furnaces.

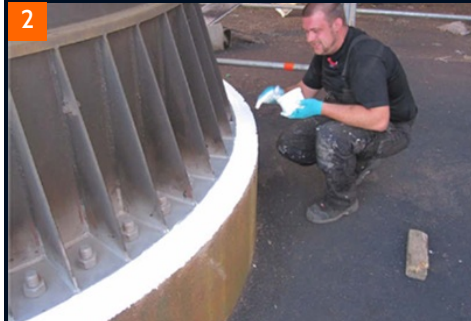
The chimneys are made of steel and are resting on a concrete base. Moisture between the chimney and the supporting concrete resulted in corrosion taking place on the chimney as well as a high risk for frost heave in the concrete.

1. Chimney Base for the furnace before the repair
2. Application of Belzona 3211
3. Reinforcement sheet incorporated into the Belzona 3211 coating bridging the steel/concrete junction
4. The finished application with Belzona 5811 providing corrosion protection on the steel chimney

Application was carried out in accordance with Belzona Know-How System Leaflets GSS-3 and TCC-5. After grit blasting the repair area, the steel was protected with Belzona® 5811 and the Belzona® 3211 reinforced system was applied across the junction between steel and concrete.
