# BELZONA RESTORES CONCRETE FLOOR

ID: 295

Wash down area floor at a facility manufacturing fasteners.

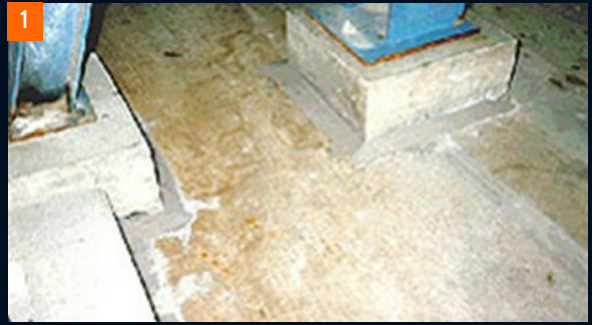
The concrete floor was beginning to show signs of degradation in the wash down area. The entire facility has a rubber liner underneath to protect from ground water contamination.

1. Cracks and penetrations rebuilt with Belzona 4111 (Magma Quartz)
2. First coat of Belzona 5811 (Immersion Grade)
3. The application is complete

The Belzona® 4111 (Magma Quartz) was used to rebuild the cracks in the concrete and tie in the penetrations through the floor. After the initial cure, Belzona® 5811 (Immersion Grade) was then used to seal the surface with two coats of beige. There are also many ground water inspection ports throughout, and the floor showed signs of deterioration after its first few years of operation, which is why they turned to Belzona.
