# BELZONA MAKES WALKWAY SAFE

ID: 2953

Walkway in production area of Cider Plant

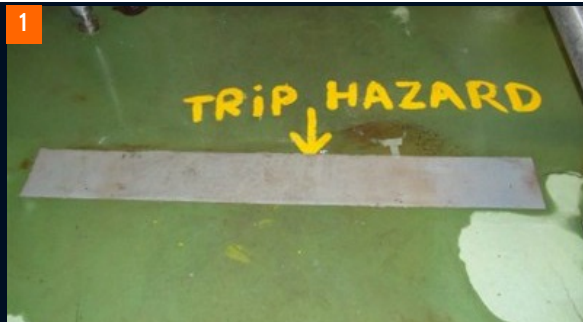
Delamination of resin floor had caused a trip hazard. When the repair was looked at they noted that there was a slip hazard in the same area.

1. Trip hazard levelled with Belzona 4131
2. Application of Belzona 4411
3. Removal of masking tape
4. Completed application.

Application was carried out in accordance with Belzona Know-How System Leaflet FPA-8. Belzona® 4131 applied to level floor area before applying Belzona® 4411 grip system.
