# BELZONA REPAIRS DAMAGED CONCRETE AT CIDER PLANT

ID: 2955

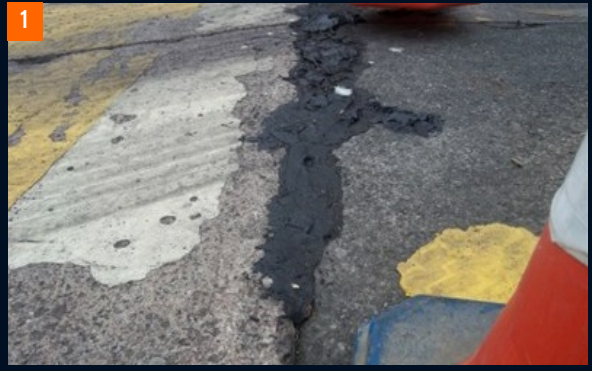
Damaged concrete on walkway was identified as a trip hazard.

Previous attempted repair Nosings rebuilt with Belzona 4131 Application of Belzona Elastomer Conditioner Completed application with joint sealed using Belzona 2211
