# OFFSHORE FLOATING HOSES REPAIRED AND PROTECTED WITH BELZONA

ID: 2959

Oil tanker offloading hose spool pieces.

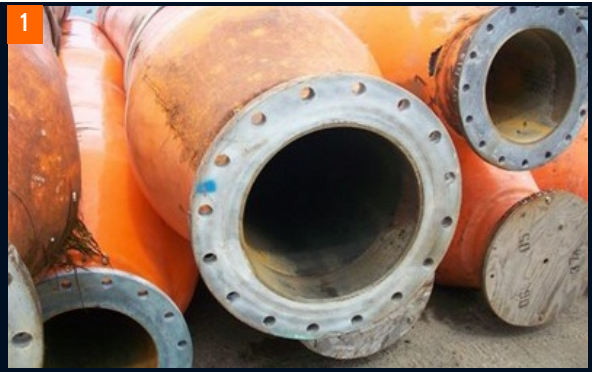
Corrosion pitting damage on flange faces caused by crevice corrosion posed a severe environmental hazard.

1. Tanker hoses awaiting repair
2. Belzona 1321 coating inside the hose
3. Completed flange face reform
4. Internal coating on spool
