# BELZONA FREEZES EXPANSION JOINT DAMAGE

ID: 296

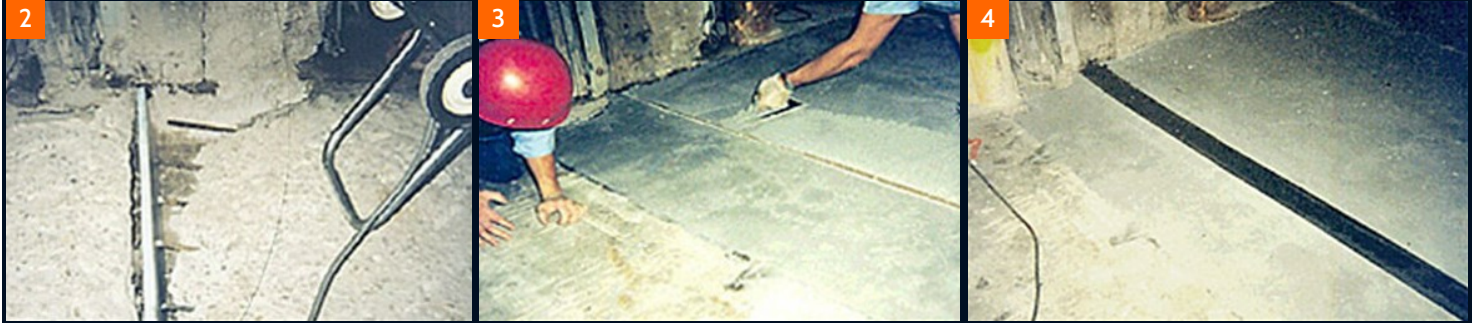
## PHOTOS

The expansion joint on the floor leading into the freezer was completely destroyed by continuous fork lift traffic as well as the freeze/thaw cycles at the frost line.

1. Significant damage to expansion joint at freezer entrance
2. Deteriorated concrete removed exposing rebar
3. Screeding in Belzona 4131 (Magma Screed)
4. Belzona 2211 used to seal the joint

The application was carried out in accordance with Belzona Know-How System Leaflets FPA-5 and FPA-6.

Belzona 4131 (Magma Screed)  
Belzona 2211 (MP Hi-Build)
