# BELZONA REBUILDS MOUNTING SURFACE OF BALL MILL JOURNAL

ID: 2961

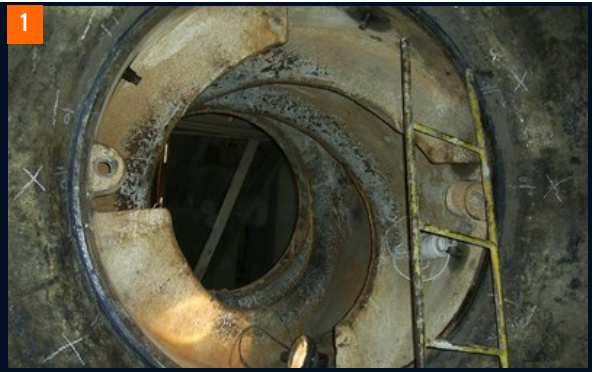
1. Sealing the inner joint
2. Sealing the outer border with metal ring. Injection ports were drilled in the ring
3. Rebuilding of the mounting surface by injection of Belzona 1321
4. Completed application with Belzona 1812 applied at the frontal interface between ball mill journal and screw insert

Application was carried out in accordance with Belzona Know-How Leaflet GSS-9. Belzona 1321 was injected into annular gap between new screw insert and ball mill journal. After that Belzona 1812 was applied at the frontal interface between insert and journal to prevent further abrasion from lime particles.
