# BELZONA HEALS HOSPITAL EXPANSION JOINTS

ID: 297

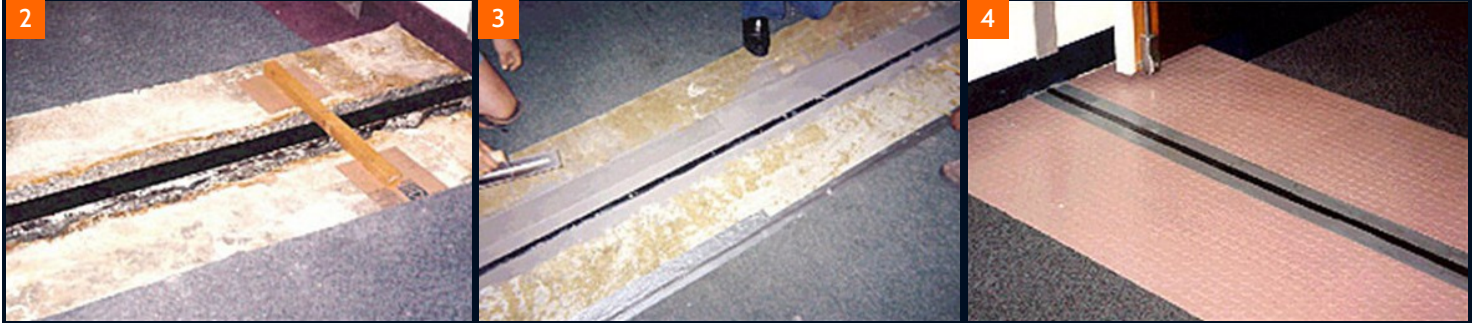
Deteriorated expansion joints cause problems with x-ray equipment as well as with individuals tripping throughout the hallways.

Deteriorated expansion joints throughout hospital hallways.

1. Joint indentation evident through carpet
2. Concrete nosings spalled from traffic
3. Nosing rebuilt and joint sealed
4. Completed application ready for traffic

The application was carried out in accordance with Belzona Know-How System Leaflets FPA-5 and FPA-6.

In all, seven joints have been refurbished using this Belzona System. This particular facility is a long term user of various Belzona Systems and was aware of the longevity of Belzona repairs.
