# BELZONA REFURBISHES SCHOOL ROOF

ID: 2971

Hall/Classroom roof on School

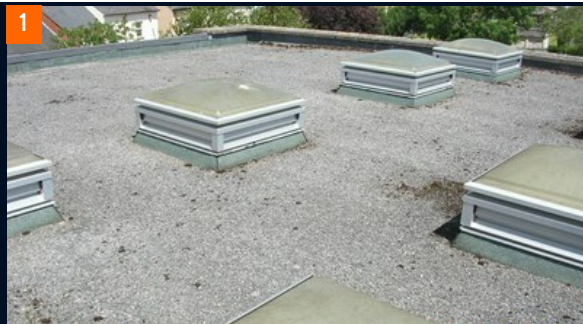
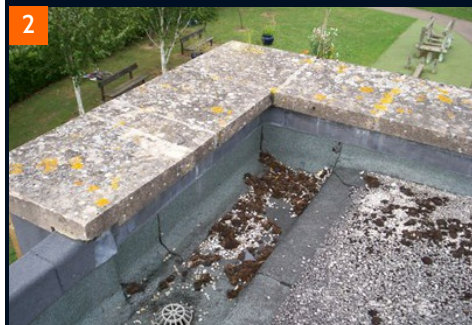
1. and 2. Before Application

Due to age and cracks in both the parapit walls and in the ashfelt the roof was leaking into the classrooms below.
