# BELZONA SUCESSFULLY UPGRADES SPIRITS CONTAINMENT AREA

ID: 2975

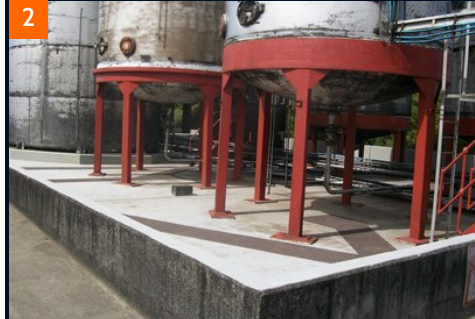
2

The existing protective system had failed. The chemical containment area could no longer be relied upon to prevent liquid loss into the groundwater/watercourse in the event of a spillage.

Containment area prior to Belzona Application  
Concrete Repairs  
Application of Belzona 5811 underway  
Completed Application

Application was carried out in accordance with Belzona Know-How System Leaflet TCC-15. Belzona® 4131 and Belzona® 4141 were used to repair the degraded sections of the walls and to create fillets to all horizontal and vertical corners of the bund. The floor was screeded with Belzona® 4131 at 6mm to provide maximum impact resistance. A two coat system of Belzona® 5811 was then applied to all the internal surfaces of the bund.
