# BELZONA SURFACED TRACK OF SETTLEMENT BASIN PASSES THE TEST

ID: 2976

Tracks of 3 primary settlement basins (total length: 324 m; width 600 mm)

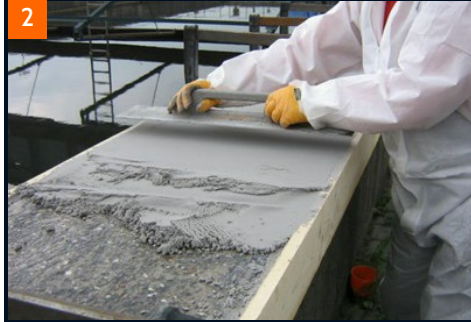
Scraper wheels and weather had caused wear to the concrete.

1. Condition of the tracks before repair
2. Application of Belzona 4111 using a float
3. Completed application
4. Track still in excellent condition after one year

Application was carried out in accordance with Belzona Know-How System Leaflets FPA-1 & 8. After preparing the top of the walls with a milling machine, the substrate was rebuilt and levelled with Belzona® 4111. The thickness varied between 2 and 50 mm. To provide additional traction for the wheels, Belzona® 5811 was applied and Belzona® 9211 added to the surface to provide a positive grip system.
