# HOSPITAL KITCHEN REPAIRED WITH BELZONA

ID: 298

Metal expansion joint or slip joint in hospital kitchen floor.

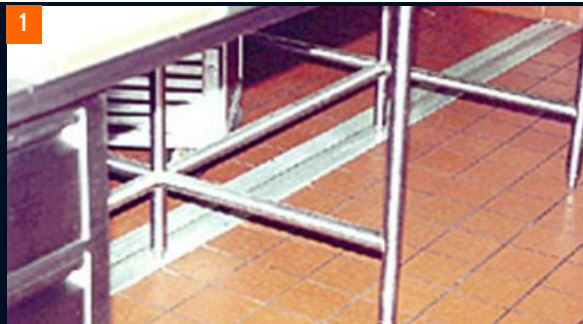
The metal expansion joint in the kitchen of this hospital had failed and the deterioration caused interruption in cart movement over the irregular sur-face.

1. Damaged metal expansion joint
2. Finished application with Belzona 4151 recently applied
3. Nosing fully cured and ready for traffic
