# BELZONA KEEPS WATER SAFE TO DRINK

ID: 299

Underground concrete water storage tank.

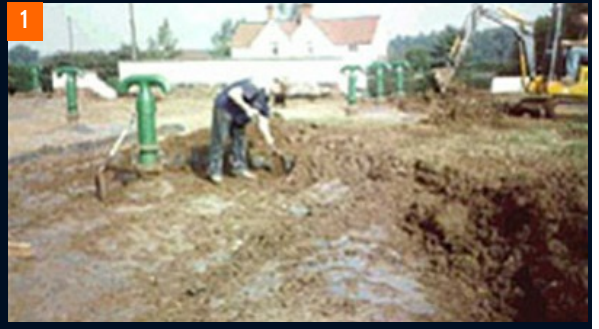
1. Excavating underground storage tank
2. Crack through roof of tank
3. Repaired with Belzona 4111 (Magma Quartz)

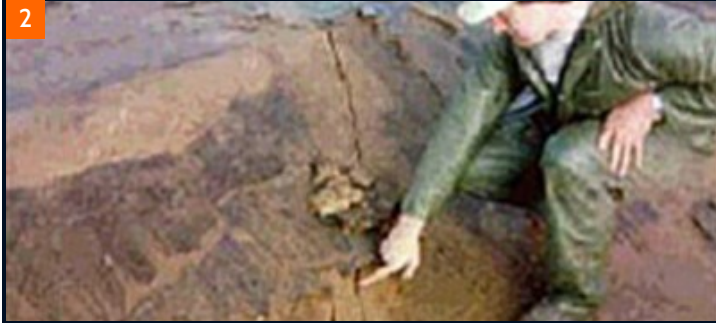
Cracks in the roof of the storage tank were allowing the ingress of surface water and contaminating the potable water contained in the reservoir. This leads to unacceptably high levels of nitrate, phosphate and miscellaneous contaminants in the tank.
