# BELZONA ROTARY WATER STRAINER WHEEL

ID: 30

Rotary water strainer wheel

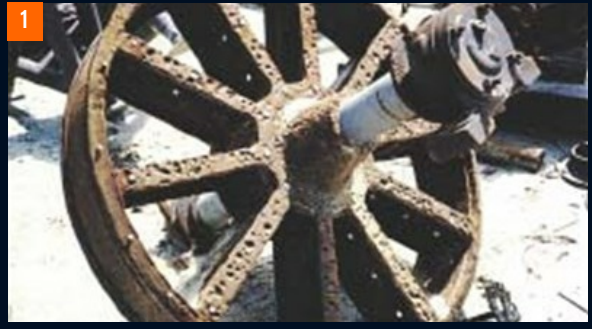
Extensive erosion/corrosion to the strainer wheel assembly which is in salt water service

1. The wheel, note the extensive erosion/corrosion
2. Application of Belzona 1311 (Ceramic R-Metal) in progress
3. Finished application with the gear assembly in place

Belzona® 1341 (Supermetalgilde) was used to hold the blast, and formers were used to rebuild the vanes. The entire wheel was rebuilt with Belzona® 1311 (Ceramic R-Metal) and overcoated with Belzona® 1321 (Ceramic S-Metal). The application saved the operation of the plant since a replacement wheel was no longer available.
