# BELZONA SEALS LEAKING CAUSTIC TANK

ID: 3007

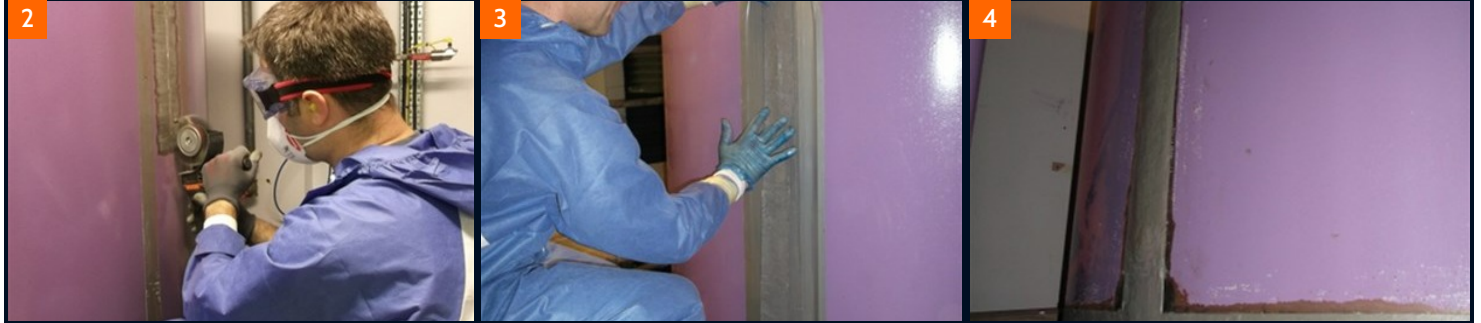
## PHOTOS

The caustic tank used as part of the process had sprung leaks along the weld seams.

1. Caustic leaking from weld seams
2. Surface preparation using MBX Bristle-blaster
3. First layer of Belzona 1111 being applied incorporating Reinforcement Tape
4. Finished application

Application was carried out in accordance with Belzona Know-How System Leaflet TCC-1.

Belzona 1111 (Supermetal)
