# STRIPPED LUG REPAIRED WITH BELZONA

ID: 301

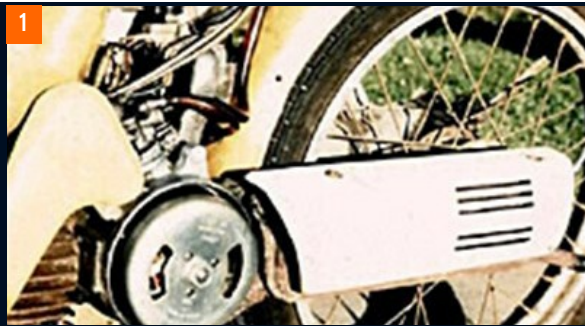
Stripped threads in casing lug of a 50cc Honda Moped.

1. View of cycle
2. Bolt being held in centralized position
3. Completed repair
