# MAJOR BELZONA SAFETY REPAIRS IN BOTTLING HALL

ID: 3010

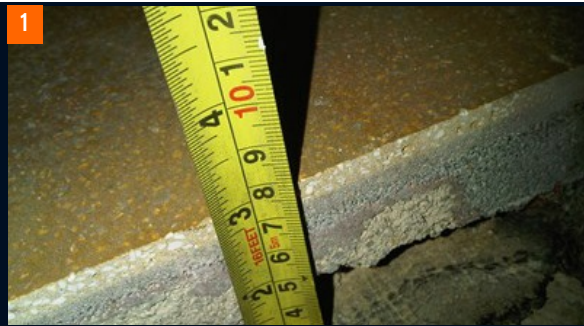
The areas were approximately 80mm deep and required filling and levelling. The three areas were a severe safety risk to the trucks operating in the plant leading to imbalance and disruption to production. The repairs had to be completed over a weekend shut-down.

Three areas of extremely uneven flooring in the bottling hall. Areas included failing quarry tiles, epoxy screed and concrete.

1. Depth and problem of repairs required
2. Concrete slabs being bedded in prior to final Belzona 4131 screed
3. Finished screed application
4. 2 coats of Belzona 5231 with encapsulated aggregate applied for safety and grip

Application was carried out in accordance with Belzona Know-How System leaflet FPA-1. After breaking out the failed epoxy flooring, quarry tiles and deteriorated concrete the levels were made up by bonding pre-cast concrete slabs into place before applying a 6mm screed of Belzona® 4131. Finally 2 coats of Belzona 5231, incorporating additional aggregate, were applied to create non-slip surface.
