# BELZONA RESOLVES WATER INGRESS ISSUES IN SCHOOL CORRIDOR WALKWAY

ID: 3011

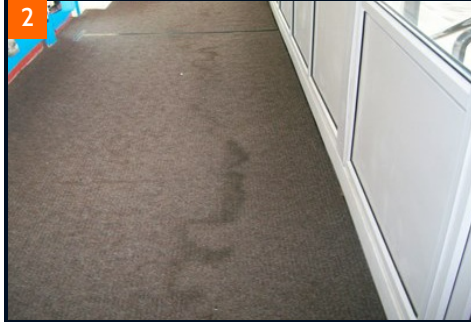
1. View of the corridor walkway from the playground
2. View from within the corridor walkway with water staining to the carpet clearly evident
3. Close up view of the main areas of water ingress
4. Completed Belzona 3131 fully reinforced application

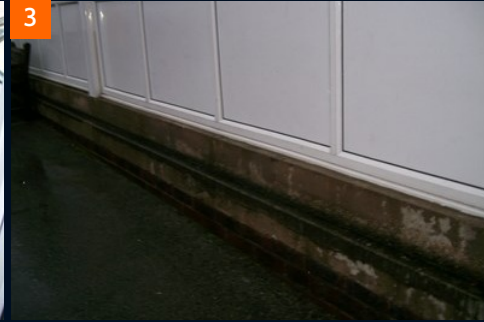
Approximately 8 years prior to the Belzona application the corridor walkways had been enclosed to provide a safe and warm environment for children and staff to travel around the school. Within a couple of years there was water ingress causing dampness to the carpeting and presenting a potential slip risk. The problem was identified as failing sealant between the UPVC panels and the original brick and cement rendered structures. Over the 6 years several attempts were made to reseal but all had failed.
