# BELZONA RESOLVES LEAKY LEAD ROOF AT UNIVERSITY

ID: 3012

Three Lead covered dormer roofs on top of large University building in the center of Manchester.

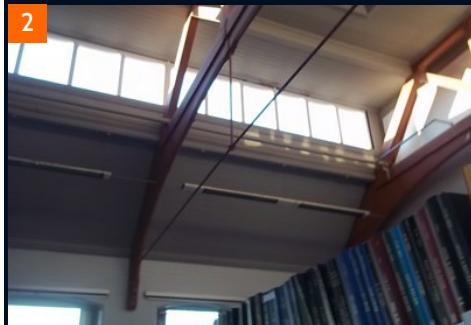
The three lead roofs were allowing water ingress into the wooden panelled ceiling below, under which there was office equipment and a library area. The client required urgent action to make the roofs water tight while not detracting from the lead roof aesthetics.

1. Initial inspection of the lead dormer roofs
2. View of the ceiling below the lead roof area
3. Application of the reinforced Belzona 3131 in progress
4. Completed application
