# BELZONA SOLVES WATER INGRESS ISSUE AT UNIVERSITY MACHINE SHOP

ID: 3013

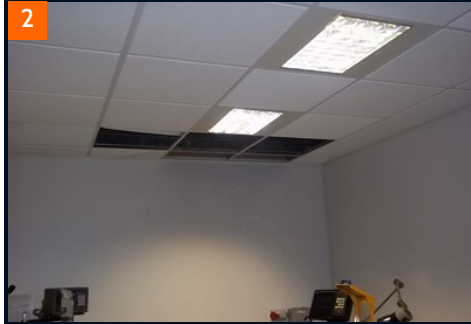
Courtyard walkway with surface water drain, the source of water ingress into laboratory machine shop below.

1. Initial inspection of the courtyard walkway and drain
2. Initial inspection of the Lab workshop directly under the courtyard walkway
3. Belzona 3131 application in progress
4. Completed application
