# BELZONA REPAIRS CORRODED GAS PIPE AT BOILER HOUSE

ID: 3014

Main gas feed pipe to boiler house at large University building.

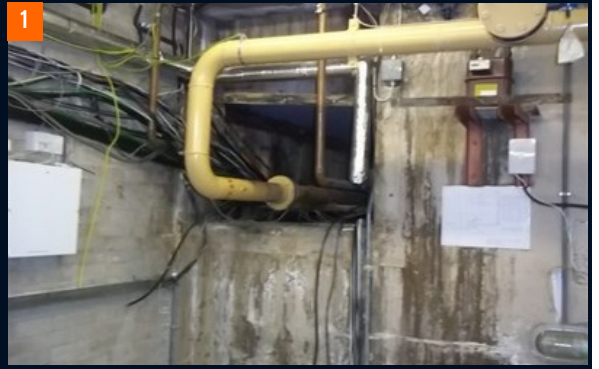
1. The entry point of the Gas pipe via a service tunnel making access and application difficult
2. Close up of corroded section of pipe
3. Completion of Belzona 1161 application
4. Completion of application including final coat of Belzona 5831

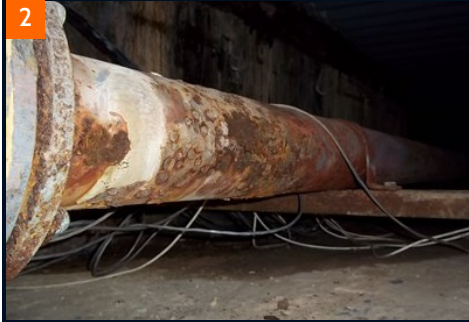
Following asbestos removal several years ago, a section of a gas main pipe had been left exposed to water ingress from above and as a result had suffered corrosion and metal loss. The client required a solution that was quick, easy and safe to apply to a live gas pipe, that would replace the metal loss and provide lasting protection from further corrosive attack.

The application was carried out in accordance with a modified version of Belzona Know-How System Leaflet VPF-11. Belzona® 1161 was applied to rebuild and protect the badly corroded section of the pipe followed by a heavy coat of Belzona® 5831 for added corrosion protection.
