# BELZONA REPAIRS THIS VACUUM PUMP AND INCREASES ITS EFFICIENCY

Water ring vacuum pump for main condenser.

Fossil fuel power station in Australia

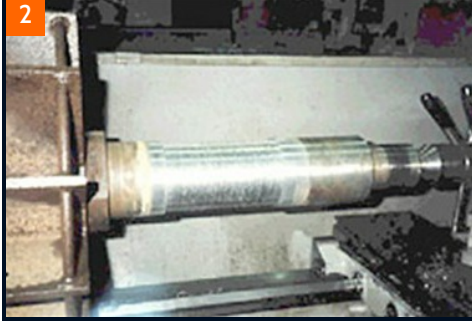
Corrosion damage to the end covers and impeller, as well as heavy souring of the gland packing locations on the impeller shaft caused insufficient vacuum pumping and loss of pressure.

1. Scored area of the shaft
2. Undercoat area of the damaged shaft
3. Application of Belzona 1131
4. The rebuilt shaft after machining of Belzona 1131

Customer achieved an increase in efficiency. In particular the end covers were rebuilt with Belzona® 1131 for additional security in service. As the clearances increase between the vanes of the rotor and the end covers, the Belzona® 1131 will prevent hang up, and provide a smooth hydrodynamic surface.
