# BELZONA REDUCES SLIP RISK ON SCHOOL STEEL WALKWAY

ID: 3027

An external steel chequer plate walkway within a school courtyard.

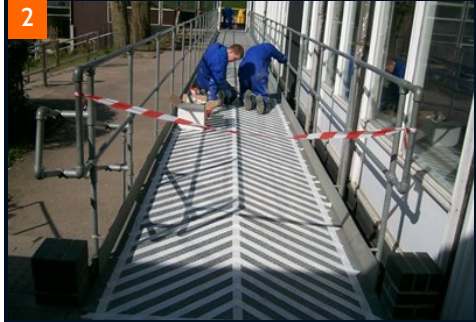
The chequer plate had become polished over time by regular foot traffic by the pupils and staff and was posing a significant slip risk to all who used it. The walkway was also used by wheelchair bound pupils and a positive grip was essential for their safe passage.

1. Situation prior to application
2. Preparation in progress, marking out of application area
3. Belzona 1821 being applied directly followed by Belzona 9221 surefoot aggregate
4. Completed grip system
