# BELZONA SAVES THIS BULL GEAR FOR A SECOND TIME

ID: 303

Bull gear and spline for 100-ton overhead crane.

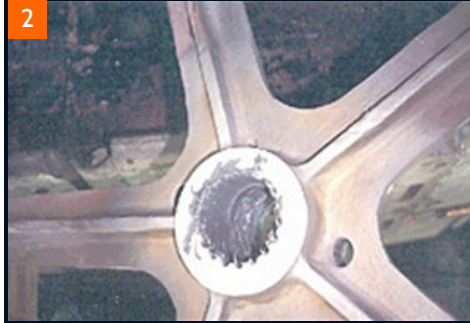
12-years prior, the assembly was rebuilt with Belzona® 1111 (Super Metal) which needed refurbishment. Excess play in the spline made it difficult for precision movements.

1. Damage bull gear spline
2. Belzona 1311 (Ceramic R-Metal) applied to socket
3. Lifting gear into position
4. Aligning bull gear onto spline

Both the male spline and the female socket of the bull gear were blasted. Belzona® 9411 (Release Agent) was applied to the spline and Belzona® 1311 (Ceramic R-Metal) was applied to both, subsequently mated, aligned and indexed. There is really no affordable alternative for this 35-year old bull gear. It would have to be custom fabricated, which is both time consuming and costly.
