# BELZONA REPAIRS DAMAGED CONCRETE IN PRIMARY SCHOOL PLAYGROUND

ID: 3032

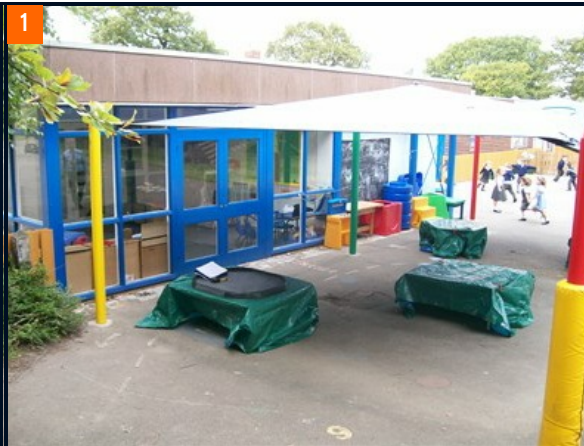
Some loose and damaged tiles had been removed in the playground bordering a class room. This had left concrete exposed and the area looking unsightly and representing a potential slip/trip issue for young children.

1. The school play/activity area
2. The damaged area to be repaired
3. Belzona 4131 repair in progress
4. Completed application

The application was carried out in accordance with Belzona Know-How System Leaflet FPA-1

Belzona 4131 (Magma Screed)
