# BELZONA SAVES COLLEGE BALCONY AND SUPPORTING LINTELS

ID: 3039

Roof area over college technology classroom that is also used as a balcony by the staff

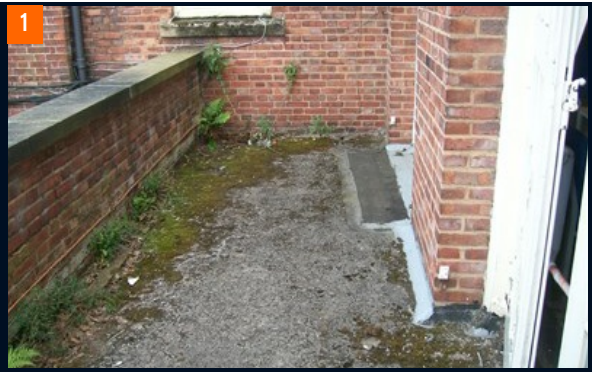
The balcony floor which also acted as a roof area for the walkway below had become porous and had been allowing water to penetrate to the ceiling and into the supporting lintels above the windows. This was causing them to spall quite badly to the point they were at risk of becoming unstable if left untreated. Several previous attempts had been made by others to resolve the water ingress by patch repairs, none of which had proved successful.

1. Balcony floor on first inspection
2. Balcony floor on completion of the Belzona 3131 application
3. The damaged lintels on first inspection
4. The lintels following Belzona 4141 repair and subsequent painting

The college were contemplating removal of the balcony and replacement of the lintels due to the degradation caused by continued water ingress. Belzona® 3131 provided a high performance long life solution that not only protects the balcony from further water ingress but due to its micro porous nature enables any trapped moisture to escape. Belzona® 4141 was used to repair the badly damaged lintels. With its high bond strength, ability to repair thick sections without the need for shuttering and impermeable nature it provides a high performance long lasting solution to damaged stone and concrete
