# BELZONA RESTORES BEARING HOUSING

ID: 304

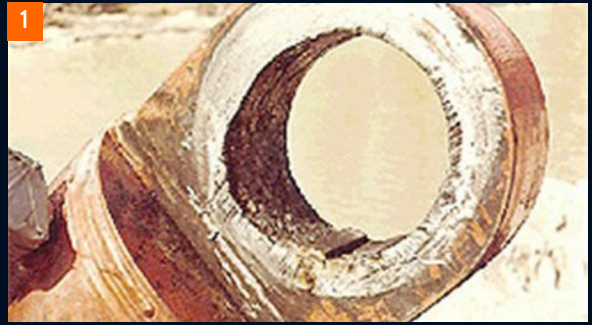
Large intermittent loads caused the bearing housing to become oblong and created a problem for the operator to effectively remove large buckets of earth.

1. Oversized bearing housing
2. Damage evident during trial fit
3. Cleaning off excess Belzona 1111
4. Finished application
