# BELZONA STAVES OFF REPLACEMENT COST ASSOCIATED WITH THIS CHIPPER

ID: 307

Klockner Rotary Chipper knife pocket wear.

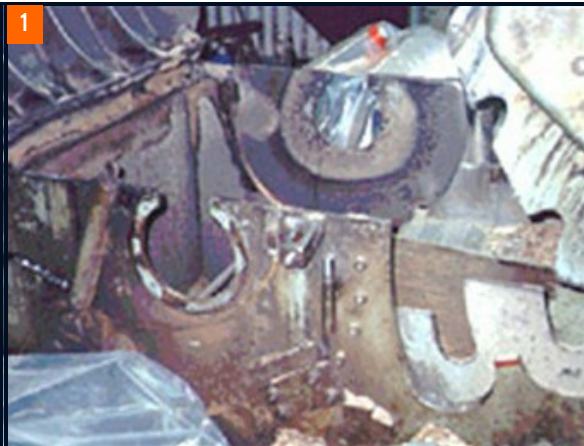
1. View of the Klockner Chipper apparatus
2. Rotor assembly with worn pockets
3. Knives removed from unit
4. Applying Belzona 1811 to pocket profile

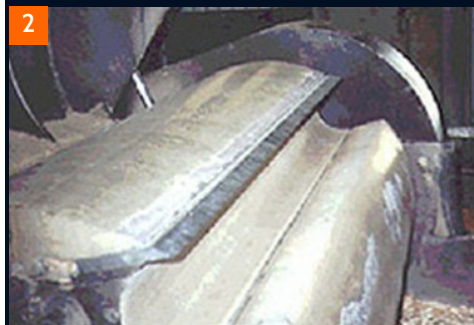
This unique chipper from Germany has 48" knives that are responsible for cutting the lumber into the appropriate chip size. Over a period of time, the knife pockets wear, causing unwanted fines and off-size chips.

The application was carried out in accordance with Belzona Know-How System Leaflet SHM-13.

Welding can cause localized heat stresses to the rotor assembly and replacement units have long procurement times since they have to be manufactured in Germany.
