# BELZONA INJECTS NEW LIFE INTO HYDRO DAM BEARING

ID: 3089

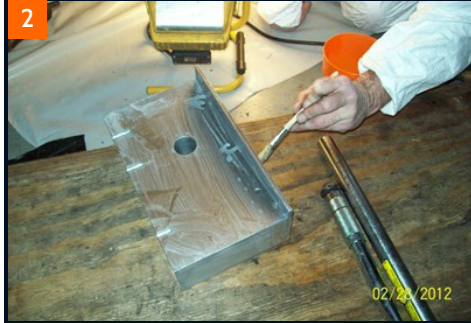
While running a high voltage test on the bearing and isolator ring a section of the bearing was damaged when a spark melted one area.

1. Close up of the damaged surface
2. Mold being treated with release agent
3. Injecting the Belzona 1321
4. Completed repair
