# BELZONA TUBE SHEET AND END COVER REPAIR

ID: 31

The tube bundle and end cover of a heat exchanger at a local refinery was badly eroded.

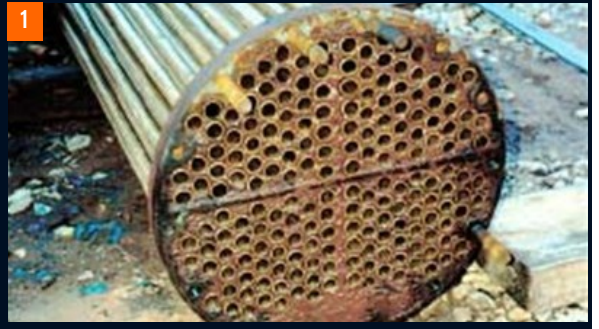
1. Eroded tube bundle prior to the repair
2. Repaired tube sheet
3. End cover rebuilt

All faces of the tube sheets were rebuilt using teflon and a steel plate as a former. The use of Belzona saved a replacement cost of approximately \$24,000.
