# BELZONA REPAIRS HYDRAULIC RAM IN SERVICE FOR OVER TEN YEARS

ID: 310

Hydraulic ram for a Layboy Table.

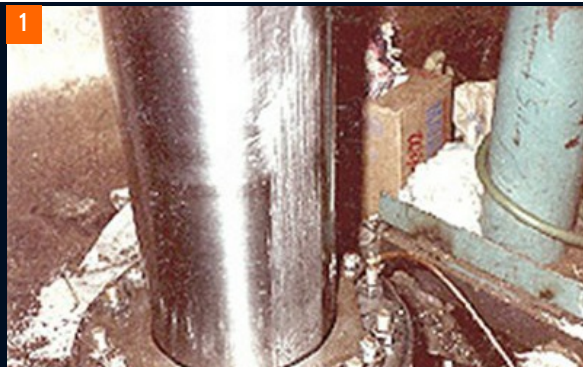
The hydraulic ram was scored due to a packing failure and was unable to build up enough pressure to raise and lower the table and transfer the stack of paper onto the conveyor system.

1. Scored hydraulic ram cylinder
2. Surface preparation with die grinder
3. Damaged area squared off
4. Finished repair
