# BELZONA GETS HEAVY EQUIPMENT BACK IN SERVICE, FAST!

ID: 312

Scored hydraulic ram for a front end loader.

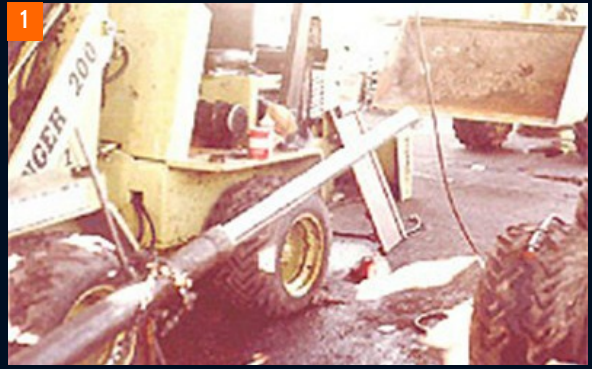
Small pieces of rock worked their way underneath the seal and scored the hydraulic ram of this front end loader. Since hydraulic pressure was not able to be maintained, this piece of equipment was out of service.

1. Damaged hydraulic ram
2. Close-up and extension of cylinder damage
3. Surface preparation with small grinder
4. Dressing down the repair
