# BELZONA REPAIRS SHAFT QUICKLY AND EFFECTIVELY

ID: 3123

Conveyor roller.

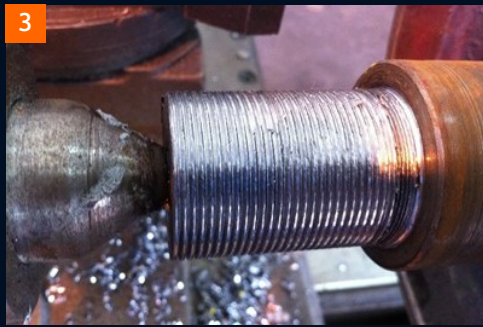
Lubrication failed and the bearing wore the shaft creating vibration. The equipment had to be stopped and the shaft repaired.

1. The roller mounted in the lathe
2. The damaged shaft end
3. Shaft prepared by rough machining
4. Belzona 1111 machined back to required diameter

The repair was carried out in accordance with Belzona System Leaflet MPT-1. The required shaft diameter was restored using machining method.
