# BELZONA RESTORES HEAT EXCHANGERS

ID: 3124

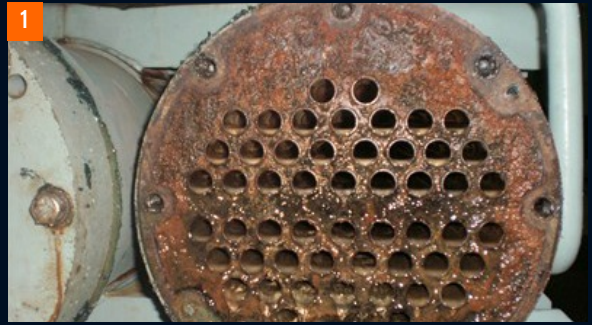
Severe galvanic corrosion on the flange face and tube sheets of heat exchangers.

1. Corroded tube sheet
2. Rebuilding surface with Belzona 1111
3. Application of Belzona 1321
4. Final result after removing corks

Application was carried out in accordance with Belzona System Leaflets HEX-1 & HEX-3.
