# BELZONA PROTECTS THICKENER FROM CORROSION

ID: 3126

Drum thickener in waste water treatment process

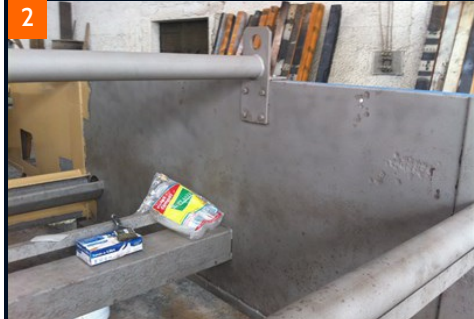
In just six months of use the equipment was already showing signs of corrosion from corrosion and chemical attack from the waste water sludge

1. Corroded thickener
2. Surface washed and grit blasted
3. Coating detail items
4. Completed application
