# BELZONA CONTAINS 98% SULPHURIC ACID

ID: 3129

Loading bay for 98% Sulphuric acid.

Chemical Plant, Porto Feliz, Brazil

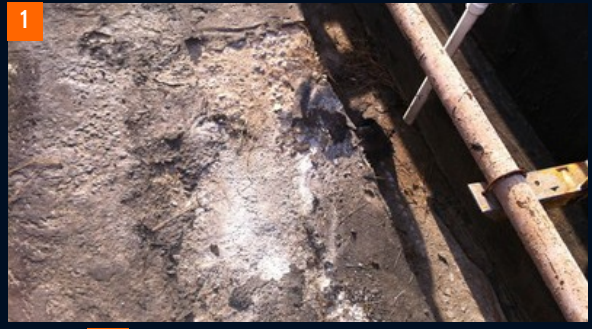
Previously used coatings had failed allowing the acid to attack the underlying concrete.

1. Failure of previously used coating
2. Surface prepared
3. Substrate conditioned with Belzona 4911
4. Finished job
