# BELZONA REPAIRS CONVEYOR BELT WITH MINIMAL DOWNTIME

ID: 314

PVC conveyor belt lap joint.

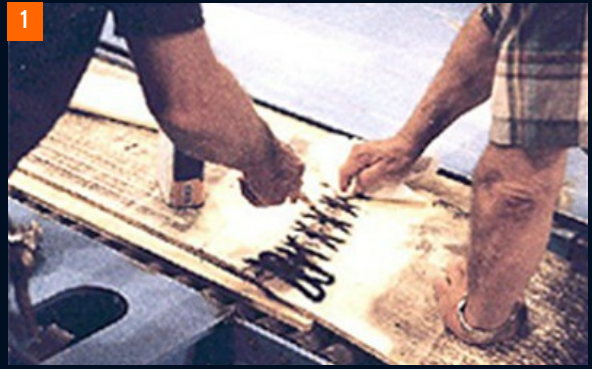
1. Cleaning and degreasing conveyor belt, lacing in place
2. Applying Belzona 2311 (SR Elastomer)
3. Finished application with belt in service

Permanent repair was made to the lap joint with Belzona® 2311 (SR Elastomer) that has USDA approval for incidental food contact during the lunch hour.
