# BELZONA PROTECTS FASTENERS OF CONVEYOR BELT

ID: 315

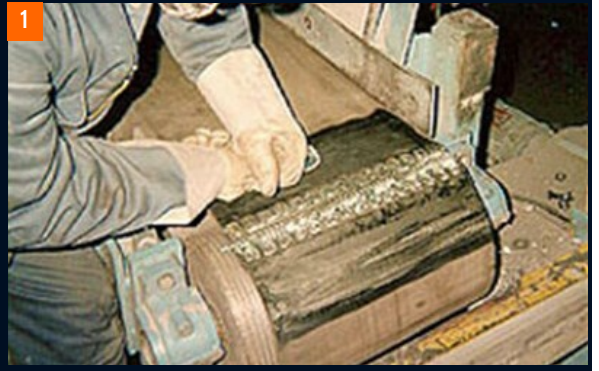
1. Conveyor belt preparation with Belzona Roughening Brush
2. Both halves conditioned with Belzona 2911
3. Application of Belzona 2211 over the hinged fastener
4. Finished application
